by Ltjg. Ben Lien

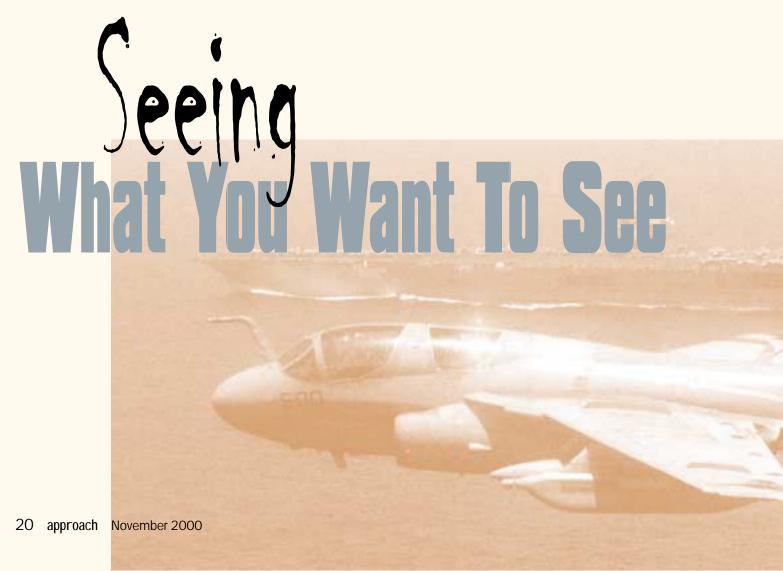
I looked over, expecting to see a barberpoled stabilizer on the IPI, but saw a solid background. "Shifted," I said to the pilot.

"No, it's still clean," he replied. I had seen a black background on the IPI, and made the mistake of seeing what I expected. Strike two for me. A shifted stab has a white background, just like the flaps-and-slats-down indicators to either side of it. If the pilot hadn't caught my error, we could have slowed into an uncontrollable descent. That's why they teach crew coordination.

The checklist called for pulling the flaps-slats circuit breaker, which is number 2 on row 4 of the pilot's circuit-breaker panel. I had written the location of each CB in my checklist next to the step that called for it when I was a RAG student. This was the first time I had needed the information, but it was worth the little effort it had taken to have it ready. Later, the pilot commented that it would have been hard to find that circuit breaker and fly if it had been night. Having the location ready for him minimized the time he had to spend with his head down reading circuit-breaker labels.

The pilot turned on the assisted-spin-recovery switch, which shifted the stab as advertised. He reset the circuit breaker, completing the checklist,
